Report on Environmental and Social Impact Assessment (ESIA) for New Kunlong Bridge Project

Prepared for:
Department of Bridge, Ministry of Construction

Prepared by:
Social & Environmental Associates-Myanmar (SEAM)

7 May 2020

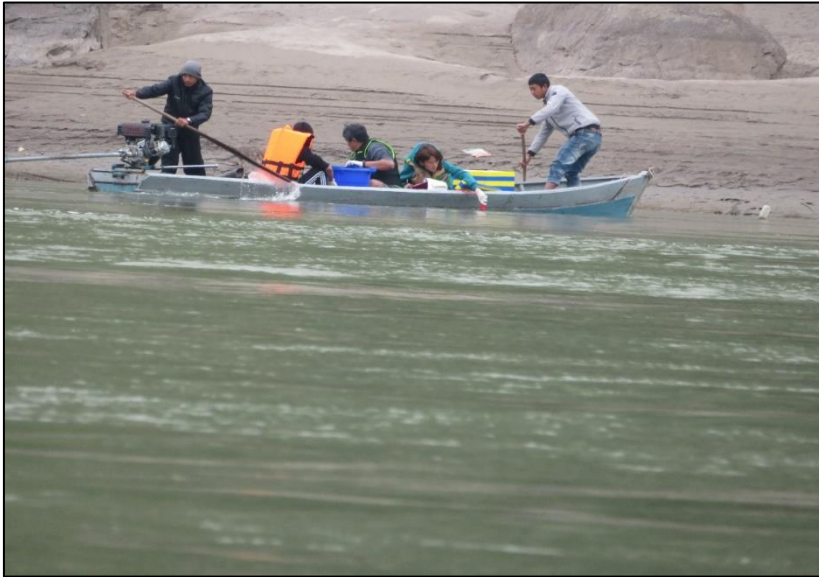
Onsite water sample collection

Water sources were geo-referenced and onsite water quality tests were performed for upstream point, downstream and the new bridge locations of the river. Portable and reliable equipment including YSI multiple parameters were carried out. For field water quality analysis, parameters specifically PH, EC, Salinity, Turbidity, water temperature, ORP, DO, and TDS together with the information for ambient air temperature and weather conditions will be measured. Array of parameters specified in NEQEG Guidelines were analyzed in a laboratory. The result of pH level is within the limited standard by NEQEG. But the result of total suspended solid in all points is over the limited standard by NEQEG for the first season while the high level of Phosphorus could be noted in both upper section and lower section of the river for the second season.
